Neville F. Rieger
Stress Technology Incorporated
Rochester, New York, USA

ABSTRACT

SOME SERVICE PROBLEMS OF TURBINE BLADES : FACTORS AFFECTING DIAGNOSIS AND CORRECTION

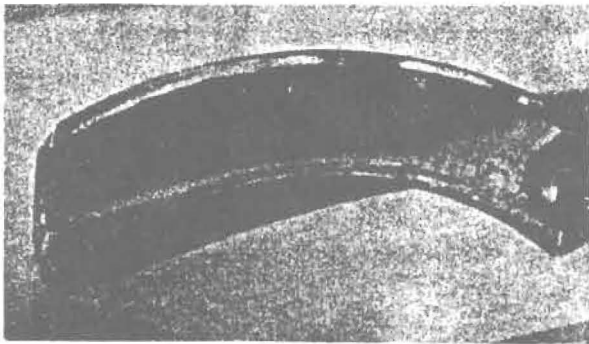
High-cycle fatigue failures can usually be recognized by visual inspection from the characteristic pattern of lines (called beach marks) which radiate from the fatigue crack site. The surface may be uniformly polished from the rubbing of the crack surfaces against each other during vibration. The surface may also be tinted, depending on whether corrosion has occurred from the gas/steam environment. Frequently there is intermittent growth of the fatigue surface. This indicates intermittent growth of the fatigue crack, showing that crack-driving excitation was not constantly applied throughout the blade fatigue life. See figure 1.

FIGURE 1. FATIGUE SURFACE WITH STAINING PATTERN.

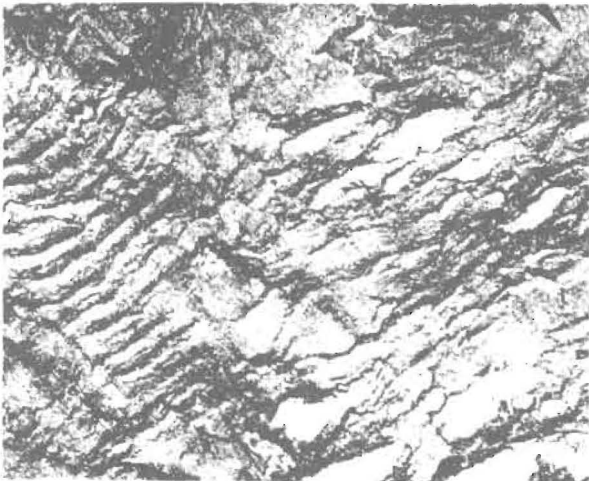
Low-cycle turbine blade fatigue failures are frequently associated with corrosion or high temperature. The influence of these effects on fatigue is discussed later. Where cyclic stresses alone have led to low-cycle fatigue failure, the progressive development of the crack can often be seen from electron microscope photographs, figure 2.

FIGURE 2. ELECTRON MICROGRAPH SHOWING FATIGUE STRIATIONS IN 4340 STEEL (BEACHAM,PELLOUX,REF.20).

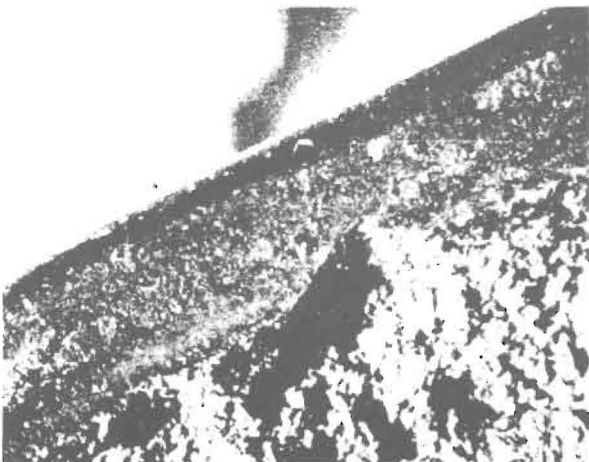
Corrosive attack on blade and disk materials arises from chemical impurities in the steam, such as sodium and potassium chlorides, sulphides and carbonates. These substances usually exist in the steam in small quantities. Efforts are made to reduce chemical impurities by water treatment. The effect of even very small quantities (parts per billion) may be concentrated by entrapment in grooves and cracks. Where such entrapment occurs at or near high-stress regions, stress corrosion may result. Evidence of concentrated corrosive attack may range from general degradation of the surface quality to corrosion failure of a component. See figure 3.

FIGURE 3. CORROSION PITS ON ROOT HOOK NEAR FRACTURE INITIATION SITE.

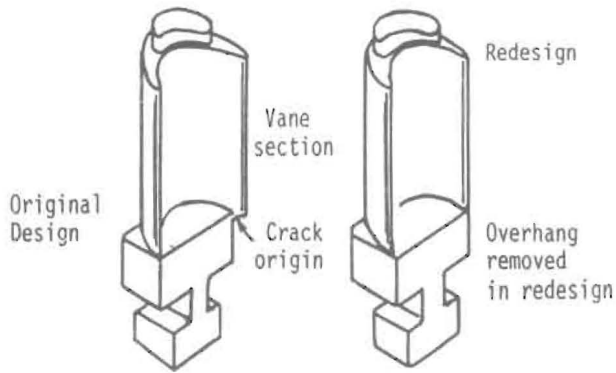
FIGURE 7. DETAIL OF FAILED BLADE AND MODIFIED REPLACEMENT BLADE, VANE OVERHANG REGION.

The overhang stress raiser was eliminated by smoothing the vane into the platform in the replacement blades, figure 7(b). Tie-wires were added by brazing to eliminate the second tangential mode from the range of nozzle resonance, fig. 8(b). Diaphragm changes (decreased number of nozzles) were also considered, but were not used because such changes were shown to be effective in removing the 8th stage alone from resonance. Also, larger nozzle passages frequently lead to higher exciting forces.

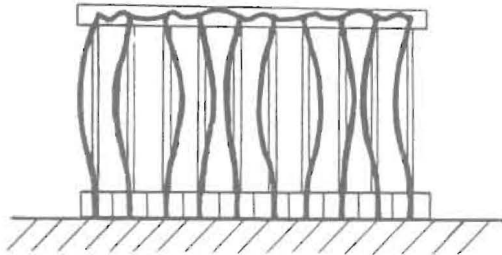
A comprehensive investigation was made of the failure. Frequency calculations and vibration tests were performed on the original blades, and on the modified blades. Much evidence was found to show that the failures were due to high-cycle fatigue from vibrations in the second-type tangential (out-of-phase) mode, figure 8(a). The cracking pattern corresponded to the calculated distribution of modal amplitudes shown, both in magnitude and location. The Campbell diagram figure 9, showed that the 8th, 9th, and 10th stages could resonate at propeller shaft speeds between 90 rpm and 174 rpm. The ship operating log, fig. 10, showed 2610 minutes of operation at 148 rpm. In this condition, the 9th stage could resonate in its second tangen-

FIG. 8(a): SECOND TYPE TANGENTIAL GROUP MODE

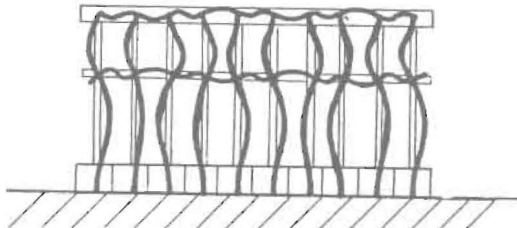
FIG. 8(b): SECOND TYPE TANGENTIAL WITH TIE WIRE

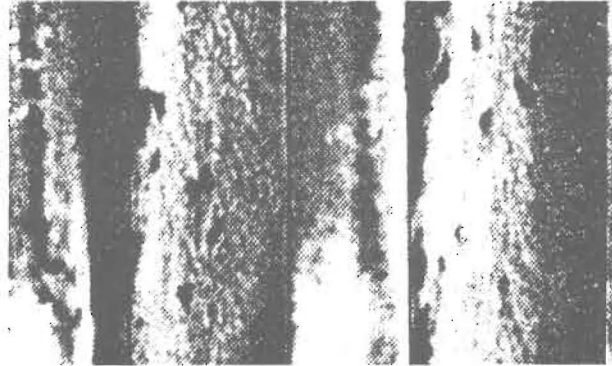
FIGURE 13. BLADE VANE SECTIONS SHOWING WHITE CHEMICAL COATINGS.

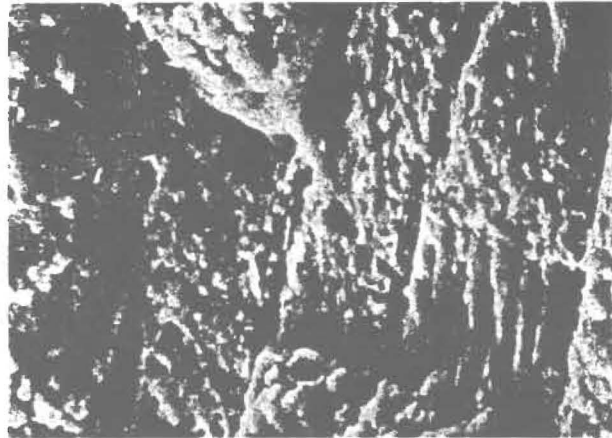
Metallographic examination showed intergranular cracking and some branched intergranular cracking inward from the highly stressed blade root notch surface, figure 14. Scanning electron microscope studies showed pitting in the vicinity of the primary fractures and secondary intergranular fractures linking the corrosion pits. The fracture surfaces were relatively clean, indicating that little rubbing or polishing had taken place since cleavage occurred. This suggests that no significant fatigue or dynamic stress mechanism was involved. The high pH, white coating were composed of NaOH, and Na_2CO_3 . This indicates that the initial cracking had been assisted by corrosion in the highly stressed hook region of the blade root. Furthermore, the original material away from the corrosion sites still had the strength and impact properties required in the original material specifications. A typical SEM photograph of the fracture surface is shown in figure 15.

FIGURE 15. ELECTRON MICROGRAPH SHOWING NaOH NODULES ON SURFACE OF CRACK.

Further investigation revealed that the boiler feedwater chemistry during operation had contained dissolved solids, iron, and sodium (77 ppb compared with 30 ppb specified), in excess of prescribed limits, despite the use of feedwater demineralizers. Stress corrosion of the blade root material under high stress conditions was the primary cause of this blade failure, based on (a) high sodium and other salt deposits, (b) wet/dry Wilson point at failure location, (c) widespread cracking in the vicinity of the high stress locations, (d) general pitting of adjacent surfaces, (e) absence of plastic flow and beach marks on the failure surface, (f) corrosion products seen in many SEM scans, and (g) corrosion fractography observed in sectioned failure regions. The principle remedy was improved steam quality and boiler feedwater chemistry by improved demineralizer control and monitoring.

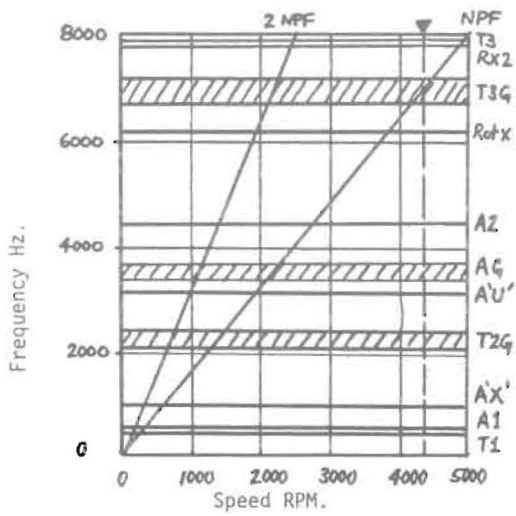
Several possible causes of these fatigue failures were identified. First, the tangential out-of-phase group modes were found to lie close to nozzle resonance, due to an inaccurate design estimate of blade root stiffness. Second, the root fillet radius of 0.031 inches was quite small, and this gave rise to high fillet stresses. Third, variations in nozzle geometry from stage arrangement around the nozzle row were found to give 4:1 variations in the magnitude of nozzle stimulus. This raises the additional possibility of per-rev stimulus from this nozzle geometry variation, but this possibly was not considered further. Fourth, a small amount of stress corrosion may have occurred judging from minor discoloration observed on the crack surface. Fifth, a further source of significant excitation was thought to have occurred from four condensate extraction ports located around the circumference, adjacent to the 4th stage moving blade row.

FIGURE 19. CAMPBELL DIAGRAM, 4TH STAGE, 96 NOZZLE DIAPHRAGM. FAILED ROW.

Design modifications were made as follows: (1) Long-arc shrouding was introduced to suppress the troublesome resonant group modes. (2) The notch fillet radius were increased to 0.060 inches to reduce the fillet stresses. (3) The inlet nozzle geometry was made uniform around the diaphragm and the number of inlet nozzles was increased from 92 to 120. (4) A flow-smoothing baffle was inserted to remove the flow disturbances created by the four extraction openings. No further failures have occurred since the introduction of these modifications.

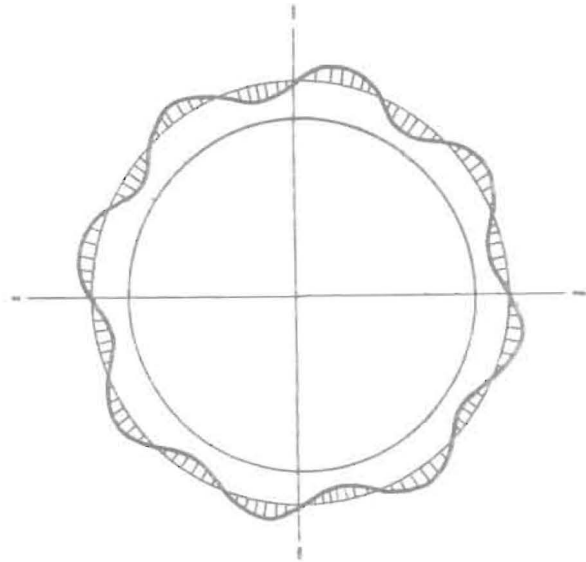
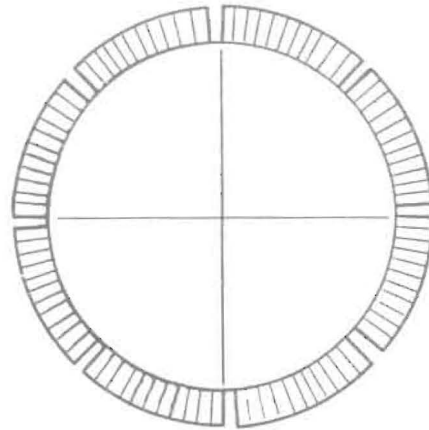
FIGURE 18. PRINCIPLE OF LONG-ARC SHROUD.

(a) EIGHT-PER-REV HARMONIC EXCITATION AROUND NOZZLE CIRCUMFERENCE.

(b) LONG-ARC SHROUDS EACH SPANNING ONE EXCITATION WAVE AT ALL POSITIONS.
