## STRESS CORROSION CRACKING OF TUBE OF A VACUUM RESIDUE STEAM GENERATOR: A CASE STUDY

H. Shaban  
Department of Chemical Engineering  
College of Engineering and Petroleum  
University of Kuwait  
P.O. Box 5969  
13060 Safat, Kuwait

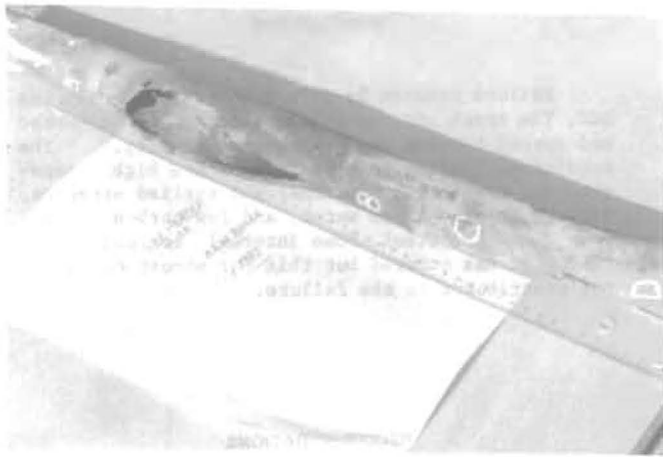
a) THE FAILED TUBE - OVERALL VIEW

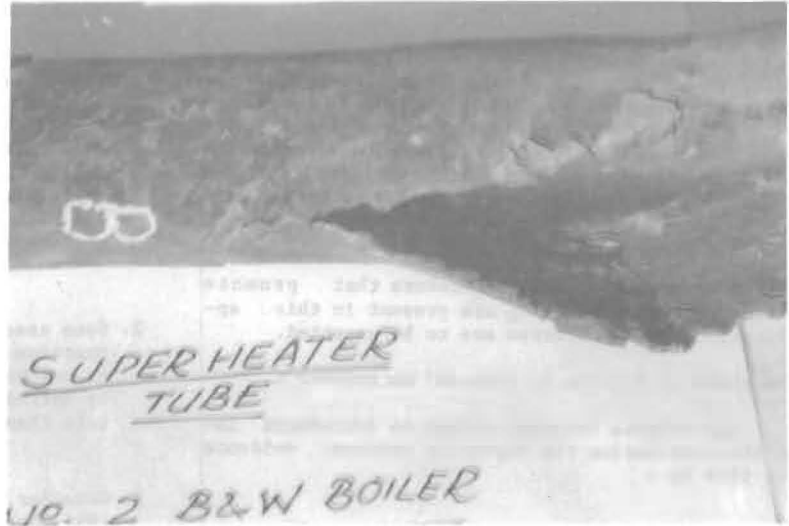
b) THE RUPTURED OF THE TUBE

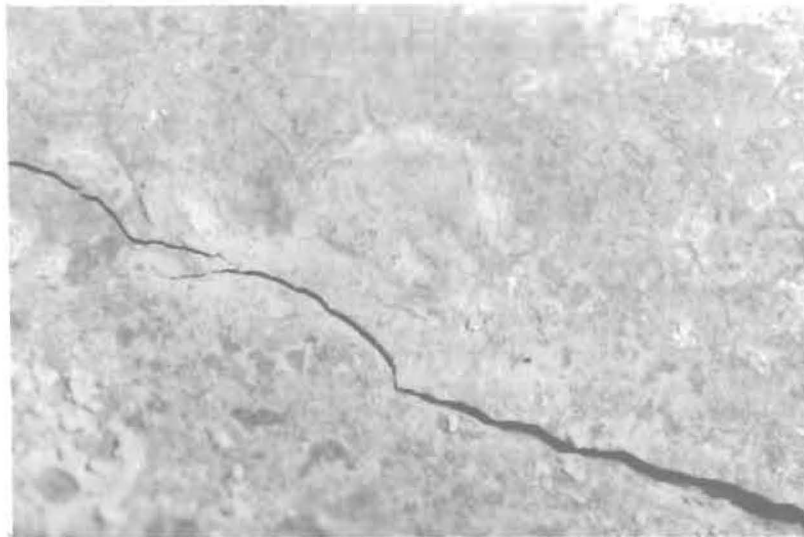
c) THE CRACK PROPAGATION AREA

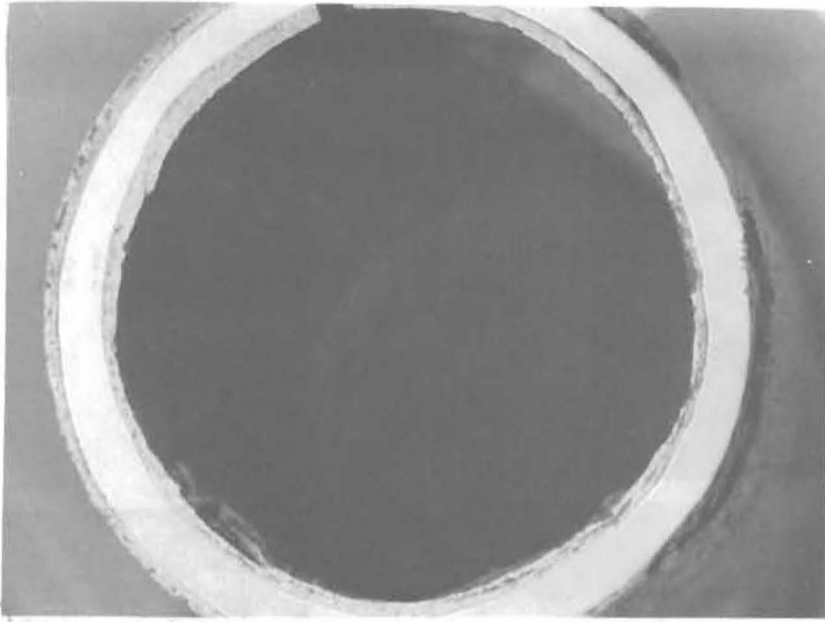
d) THE TUBE THINNING

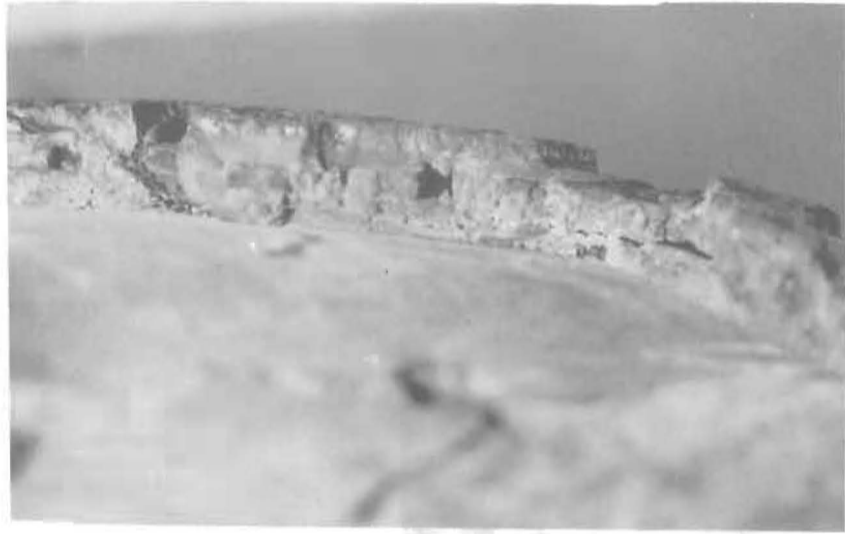
e) SCALES ON THE OUTER SURFACES

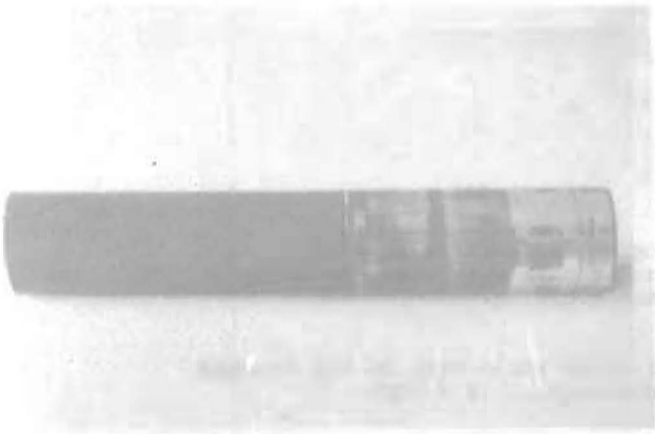
Figure (1)

A number of tube failures occurred in two steam generators after a short period of service. Most of the failures were in the hot zones and towards the outside of the bundles. All the removed tubes showed transverse fracture which was located adjacent to the expanded section of the tubes as shown in figure (1). The right hand end of the tube is the section that was expanded into the tube sheet hole by a process of roller expansion over the first 2 inch of the tube length. The outer surface of this section is fairly bright. The fracture is adjacent to this section. The remainder of the tube shown in the figure extends into the main body of the generator.

General view of tube showing expanded section, fracture and uniform cracking on the outer surface of tube in contact with water.

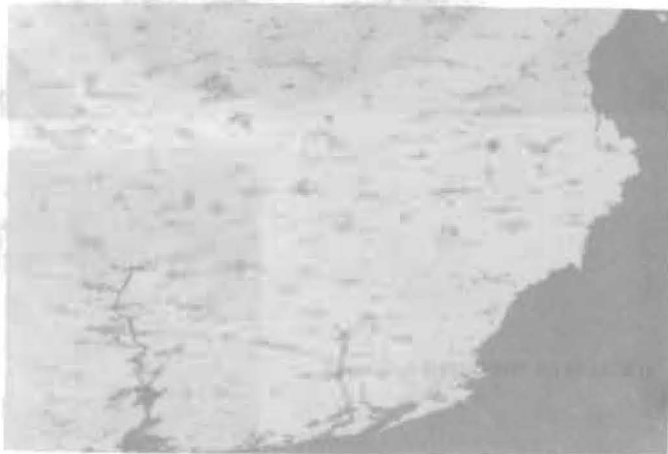
Figure (3)

Cross-section through the outer surface of expanded portion of the tube showing pittings and cracking ... (X = 200)

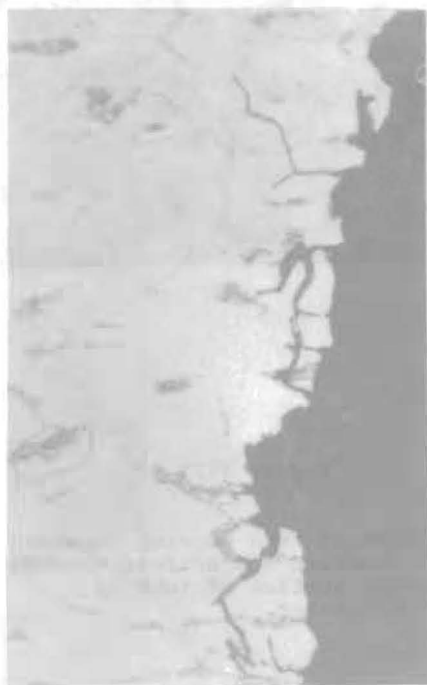
Figure (4)

A more detailed examination of the outer surface was carried out on a cross section of the tube. Figure 6 shows the outer surface in the expanded portion of the tube; the surface is quite smooth and free of pits. On the other side of the fracture face this surface showed deep pits with cracks beginning to spread from some of them; one such crack is shown in Figure 4.

Cross-section of fracture showing intergranular path with some branching into adjacent grains.

Note: the oxide scale with in the cracked boundaries... (X = 500)

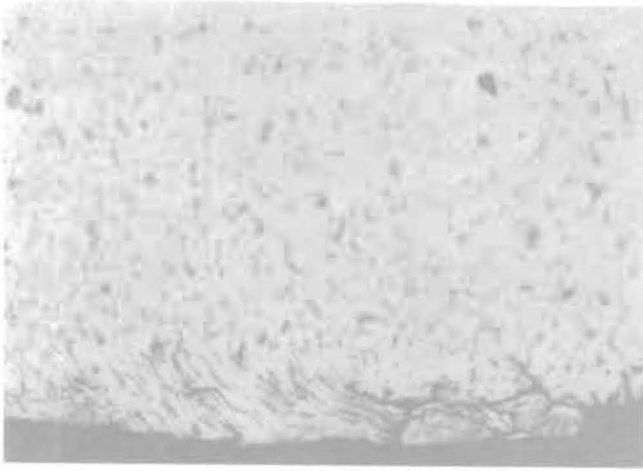
Figure (5)

On a part of the outer surface remote from the fracture there was found to be a region of localised deformation and associated cracks (Figure 5).

Deformed region of the outer surface remote from the fracture showing some cracking .... (X = 200)
