Neville F. Rieger
Stress Technology Incorporated
Rochester, New York, USA

ABSTRACT

SOME SERVICE PROBLEMS OF TURBINE BLADES : FACTORS AFFECTING DIAGNOSIS AND CORRECTION

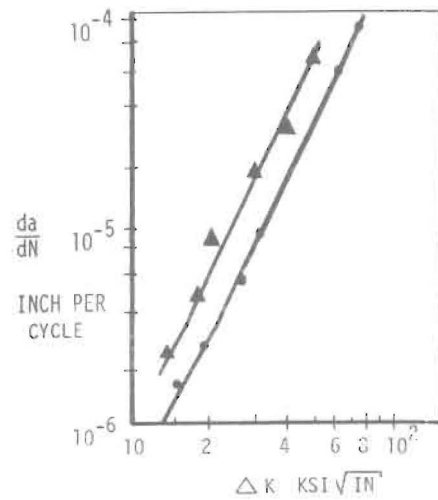
FIGURE 4. CRACK GROWTH DATA FOR 304 STEEL IN AIR AND 3 PERCENT NaOH SOLUTION (BARSOM,NOVAK,REF 20).

σ_{max} and σ_{min} are the maximum and minimum values of the total stress at the location in question. A typical relation between da/dN and ΔK for a 4340 steel in a three-percent caustic solution is shown in figure 4. This chart does not include the effect of mean stress ratio R . In most cases the stress field in the body changes with distance into the body. This causes the stress at the crack tip to change and so influences the rate of crack propagation. Calculations with each of the above factors which must include the effect of variation are most conveniently performed with a suitable fracture mechanics computer program, such as the CRACKS (11) or BIGIF (12). The end result of such a calculation is a value for a specific number of cycles to propagate the crack, either to failure when $K_{max} = K_{IC}$ (fatigue) or K_{ISCC} (corrosion fatigue), or until a length is reached at which the crack stops propagating.

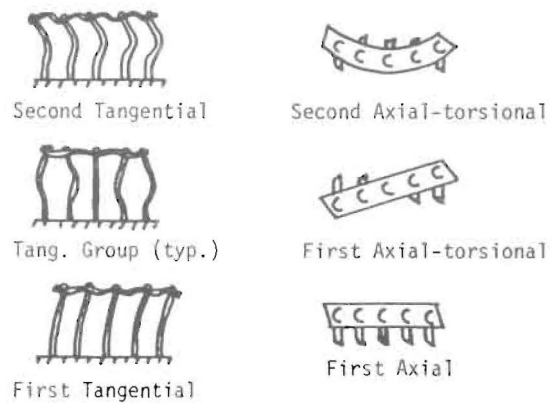
FIGURE 6. MODE SHAPES OF TURBINE BLADES IN GROUPS.

Consider a group of blades rotating in an axial flow turbine, figure 6. The total stress at any location is due to two sources, the steady mean stress σ_m and the dynamic or alternating stress σ_a . At any instant during operation, this total stress is given by:

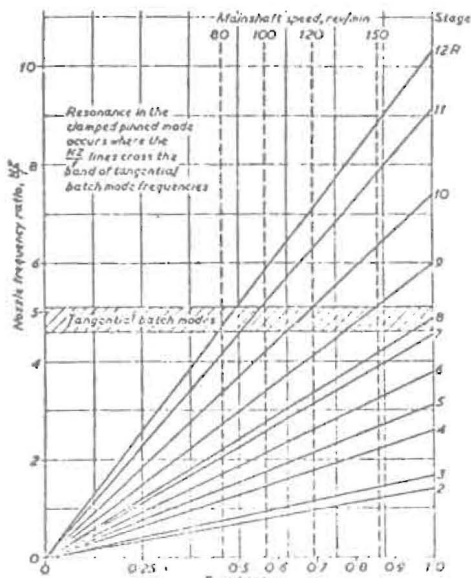
FIGURE 9. CAMPBELL DIAGRAM FOR FATIGUED MARINE TURBINE BLADE (FLEETING, COATS, REF. 13).

A comprehensive investigation was made of the failure. Frequency calculations and vibration tests were performed on the original blades, and on the modified blades. Much evidence was found to show that the failures were due to high-cycle fatigue from vibrations in the second-type tangential (out-of-phase) mode, figure 8(a). The cracking pattern corresponded to the calculated distribution of modal amplitudes shown, both in magnitude and location. The Campbell diagram figure 9, showed that the 8th, 9th, and 10th stages could resonate at propeller shaft speeds between 90 rpm and 174 rpm. The ship operating log, fig. 10, showed 2610 minutes of operation at 148 rpm. In this condition, the 9th stage could resonate in its second tangen-

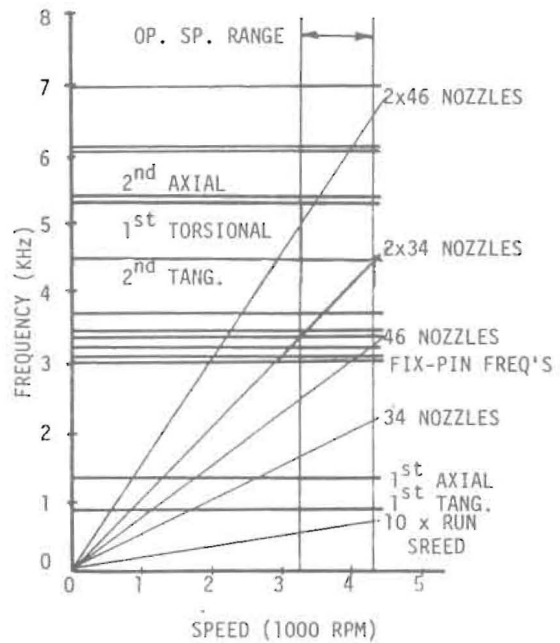
FIG. 11(a): CAMPBELL DIAGRAM FOR FAILED BLADES

Analysis showed that the second in-phase tangential mode of the blade group coincided with NPF at full operating speed with the 34-nozzle diaphragm. Further, the Campbell diagram, figure 11, showed that although a change from 34-nozzle openings would cease to excite the second in-phase tangential group mode with the second HPF harmonic (2x34), the (1x46) NPF harmonic would then excite several second-type tangential (out-of-phase) modes.
